FIRE DOOR
GAP SOLUTIONS

Simpler, Smarter and Safer

UL CERTIFIED FOR UP TO 90 MINUTES

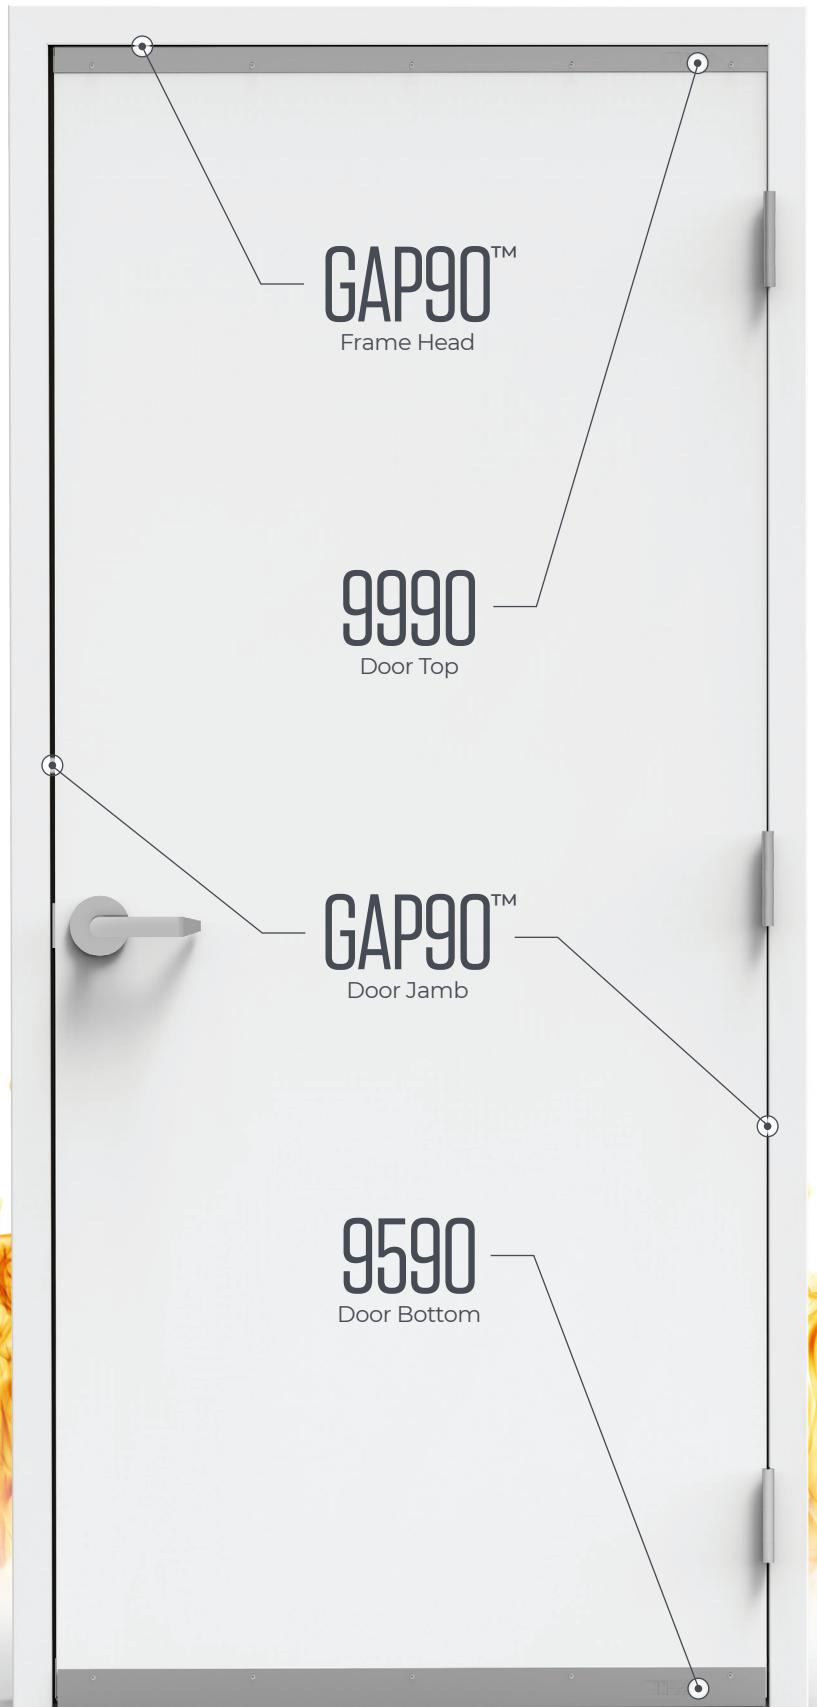
NGP'S UL CERTIFIED 90-MINUTE FIRE DOOR GAP SOLUTIONS WILL HELP YOU AVOID THE COST, LABOR AND DISRUPTION OF REPLACING EXISTING STRUCTURES TO ACHIEVE COMPLIANCE. WHETHER AT THE HEAD, JAMB OR DOOR BOTTOM, EXCESSIVE GAPS PUT LIVES AT RISK. NGP'S GAP90™ (HEAD/JAMB), 9590 (BOTTOM) AND 9990 (TOP) HAVE YOU COVERED FROM EVERY ANGLE.

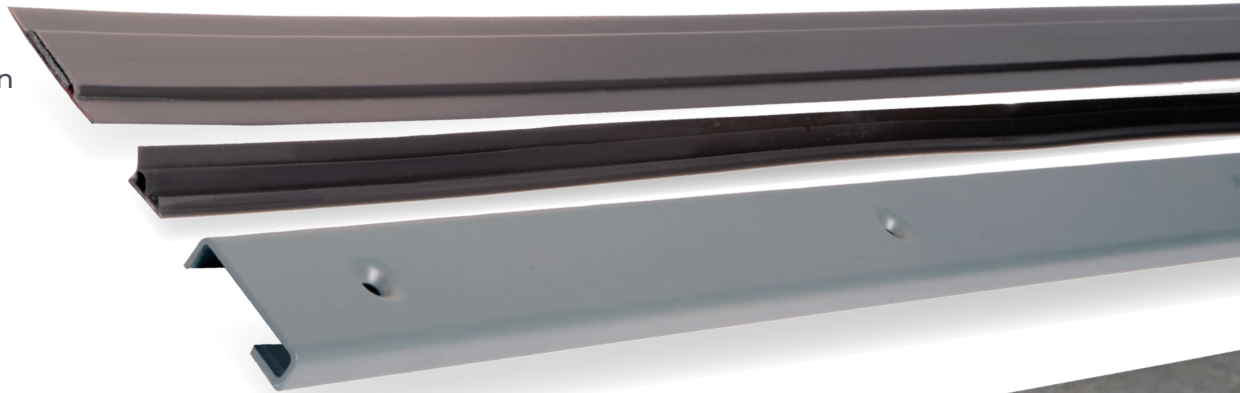
GAP90™

Head/Jamb
Gap Solution

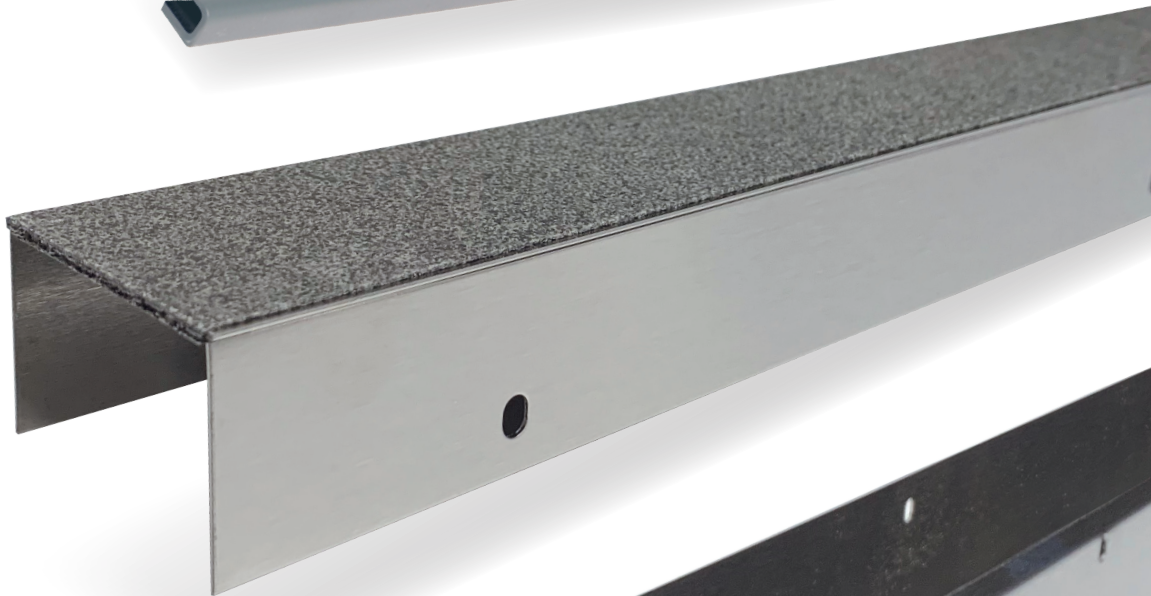
9990

Door Top
Gap Solution

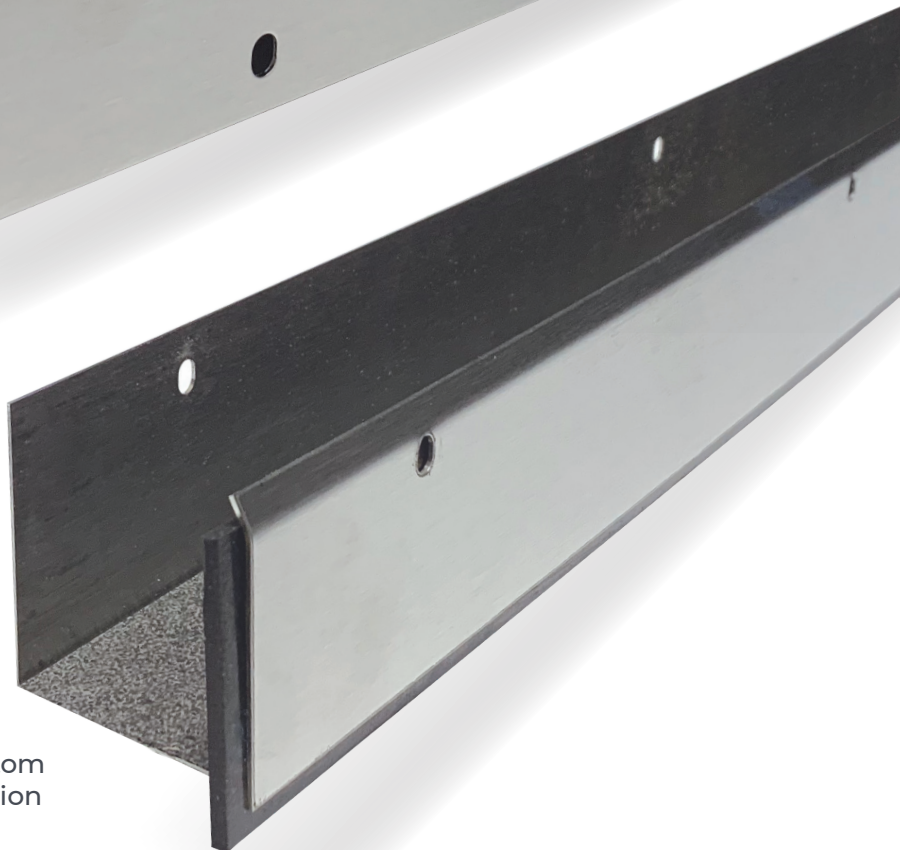
9590

Door Bottom
Gap Solution

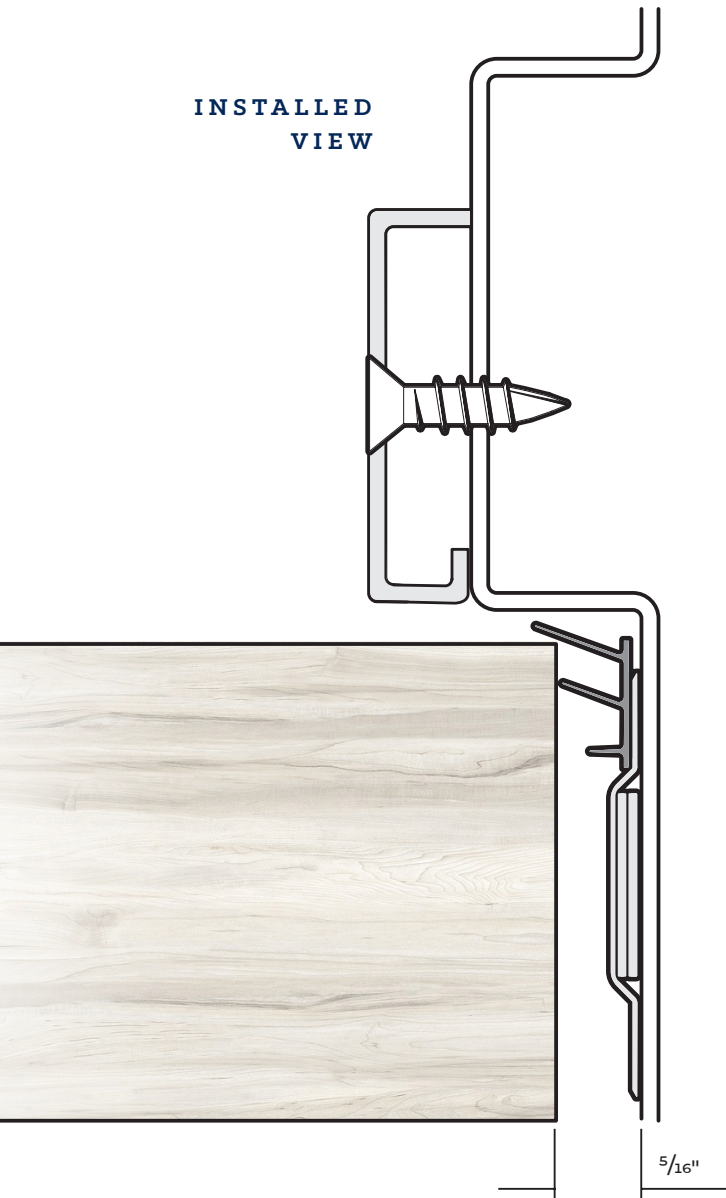
INSTALLED
VIEW

FIRE DOOR HEAD AND JAMB GAP SOLUTION

UL Certified Solution for Fire Doors with Excessive Clearance Between Door and Frame Over 1/8", up to 5/16".

PRODUCT CONSISTS OF:

9945

Steel Stop Extender

- ▶ 16-Gauge, Gray Primer Finish
- ▶ Furnished with #10 X 1" TEK SMS
- ▶ Patent No.: US9,273,510B2
- ▶ Embossed with **UL Mark**

5075

Self-Adhesive TPE Seal

9400

NGP-Edge® Intumescent Seal with PVC Cover

90-Minute rated UL Certified Miscellaneous Fire Door Accessory on UL10B and UL10C wood or hollow metal fire doors.

GAP90™ is only needed in areas where gaps exceed compliance. It is often aesthetically desirable to run the Steel Stop Extender (9945) full length of head or jamb, while applying the Intumescent (9400/9400DKB) and TPE Seal (5075CL/5075B) where the gap is excessive.

The intention of the hospital stop is to allow for easy cleaning of the area where the frame meets the floor. The Steel Stop Extender component (9945) should stop at the miter for the same reasons as the actual hospital stop. The Intumescent component (9400/9400DKB) should continue to the bottom of the frame. Optionally, the TPE Seal (5075CL/5075B) may stop at the miter or continue to the bottom of the frame.

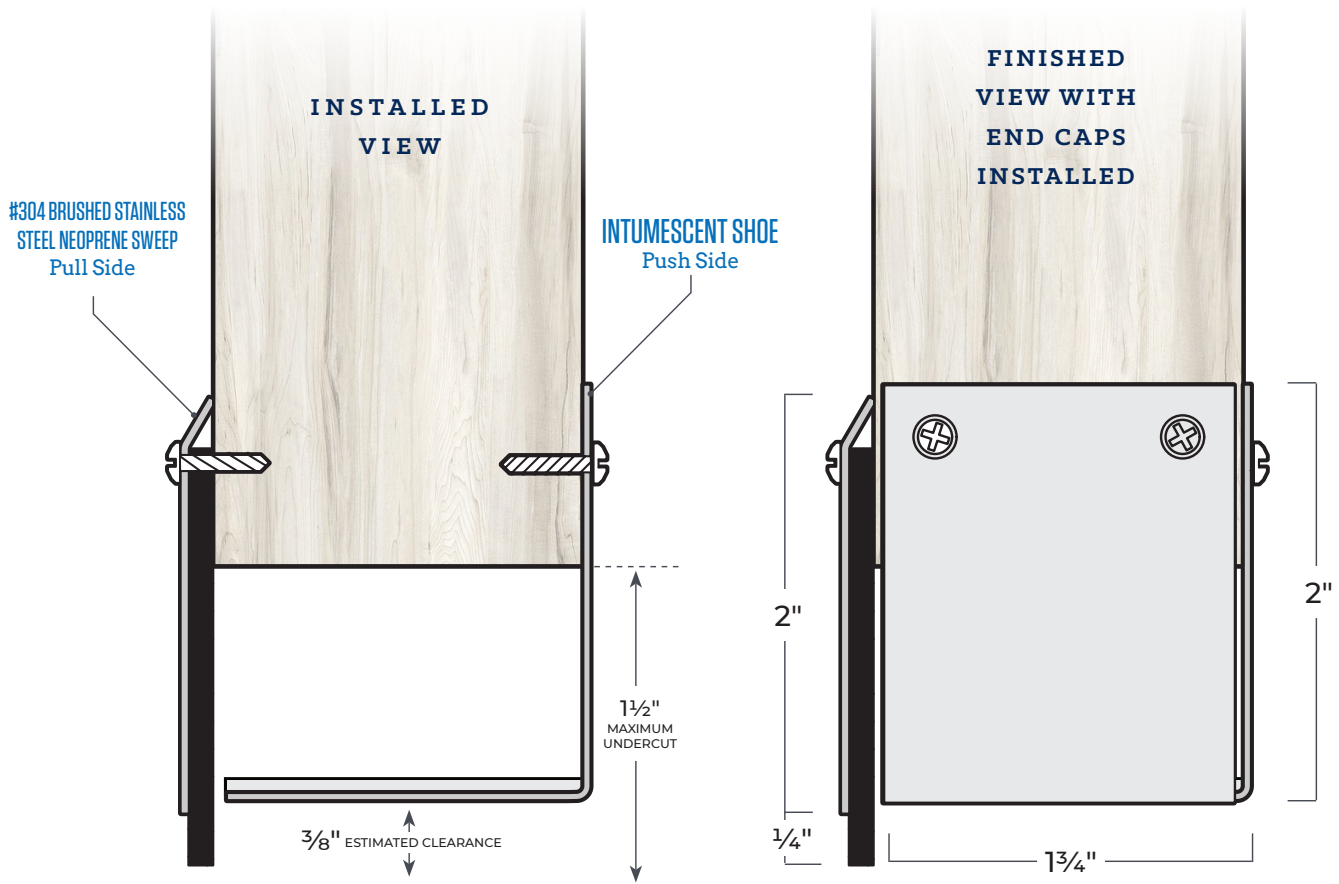
9590

FIRE DOOR BOTTOM GAP SOLUTION

UL Certified for Door Bottom Gaps — Measuring up to 1 1/2".

- Restricts the passage of smoke
- 90-Minute Rated — for use on UL10B and UL10C wood or hollow metal fire doors
- Patent Pending
- Available in 36" and 48" lengths
- Non-handed

- + #304 Brushed Stainless Steel Neoprene Sweep - Pull Side
- + #304 Brushed Stainless Steel Intumescent Shoe—Push Side
- + #304 Brushed Stainless Steel End Caps
- + #6 x 3/4" Stainless Steel SMS Furnished
Brushed stainless steel
Neoprene is black

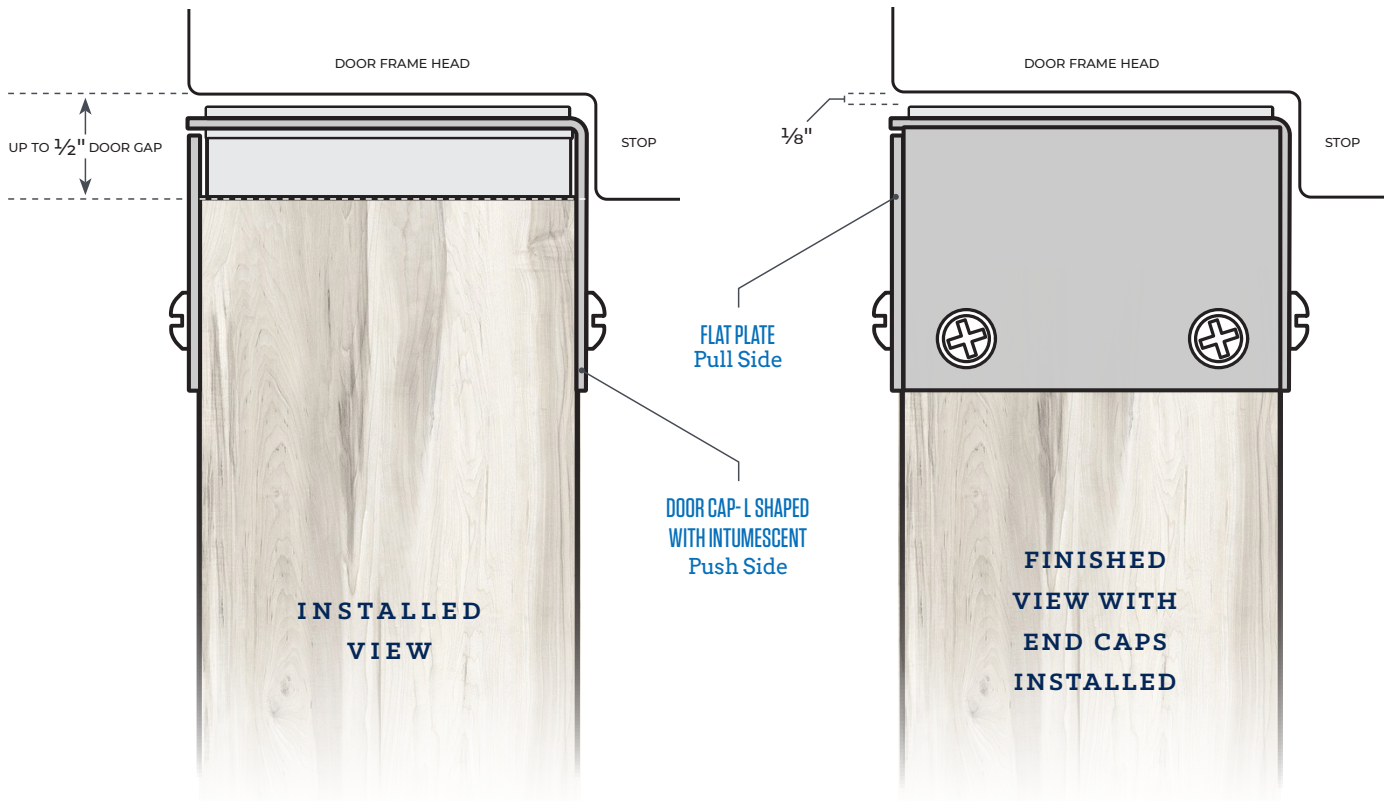
9990

FIRE DOOR TOP GAP SOLUTION

UL Certified for Door Top Gaps — Measuring up to 1/2".

- ▶ 90-Minute Rated— for use on UL10B and UL10C wood or hollow metal fire doors
- ▶ Recommended for doors with parallel arm closers
- ▶ Patent Pending
- ▶ Available in 36" and 48" lengths
- ▶ Brushed stainless steel
- ▶ Non-handed

- + #304 Brushed Stainless Steel Flat Plate - Pull Side
- + #304 Brushed Stainless Steel Intumescent Cap—Push Side
- + #304 Brushed Stainless Steel End Caps
- + #6 X 3/4" Stainless Steel SMS Furnished
